NAVAL RESEARCH LAB WASHINGTON DC

NRL-MR-4473

## ULTRASONIC INSPECTION OF A GRAPHITE/EPOXY STRUCTURAL MEMBER USING A THICKNESS-IMAGING DEVICE

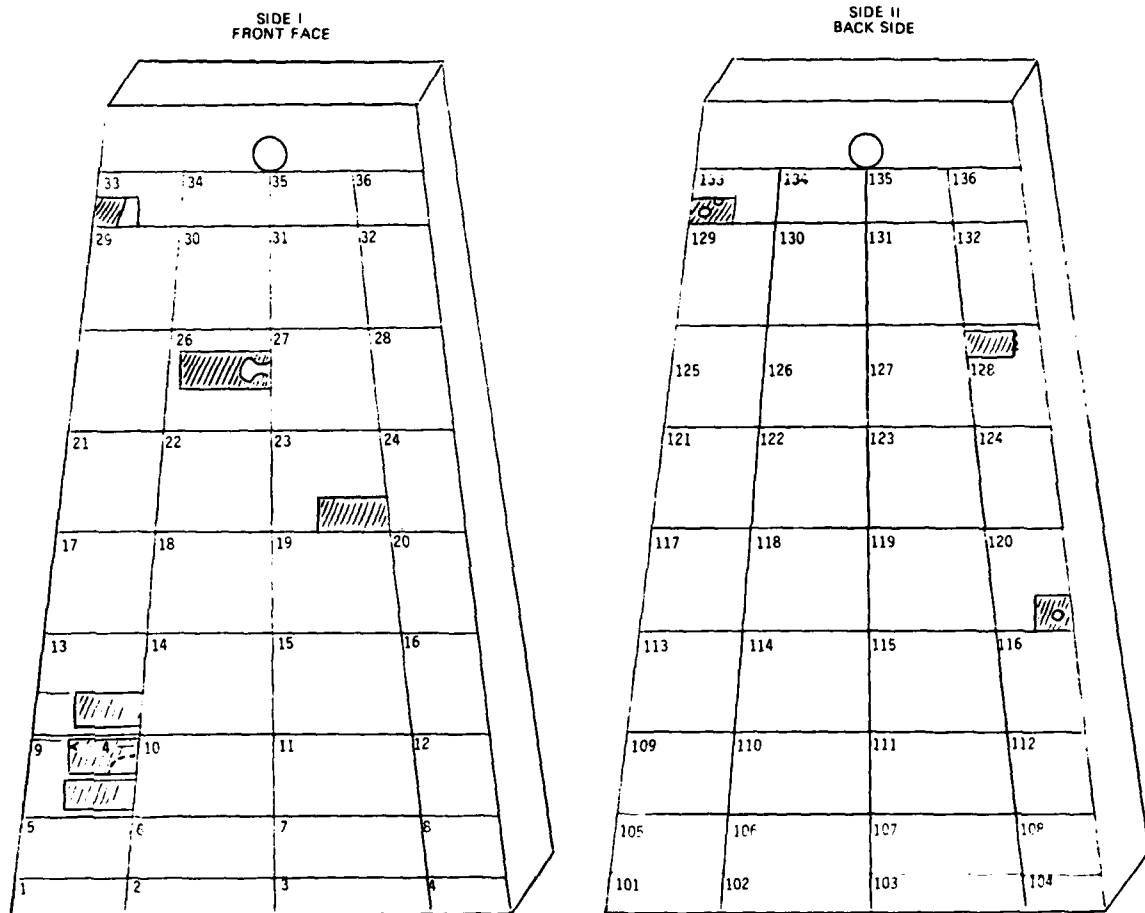
Fig. 5 — Grid sections drawn on the composite faces. The shaded areas are those sites chosen for the SCIMI inspection.

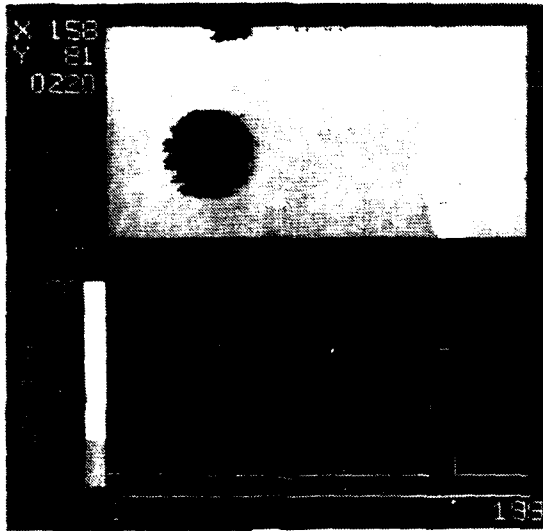
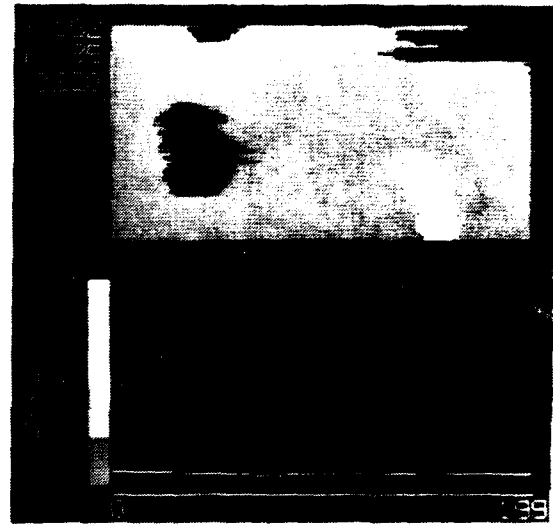
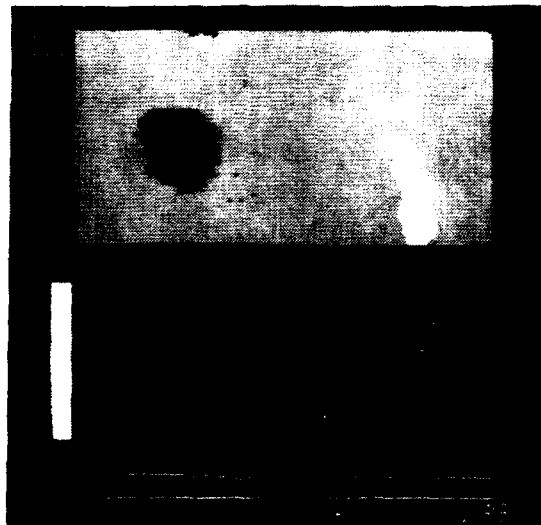
Fig. 8 — Three scans from site 133

Shown in Fig. 8 (a,b,c) are the images created by the SCIMI instrument. Information concerning the mapping parameters is shown in Table 2. The letters a, b, c, in Fig. 8 represent the three scans taken; (a) is the baseline scan and (b) and (c) are the subsequent scans after each loading cycle. A dark circle on the left side is the area where the bolt was located. The white region is the delaminated area, with a black cross marking the region where depth and location information is to be analyzed. Shown on the upper left are the x and y reference locations and the number, 0.220, is the depth of the delamination in inches. On the lower portion of the image is a depth scale along the x axis depicting the 5 scale grey levels taken from the cursor location. As can be seen, the images of the delamination are remarkably similar, even though the three scans were not physically started at identical locations.

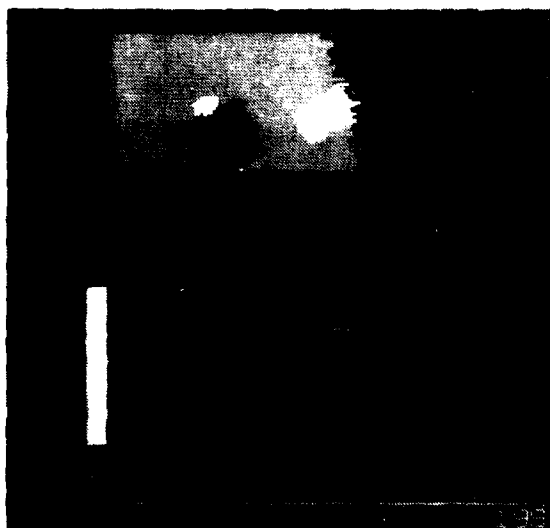
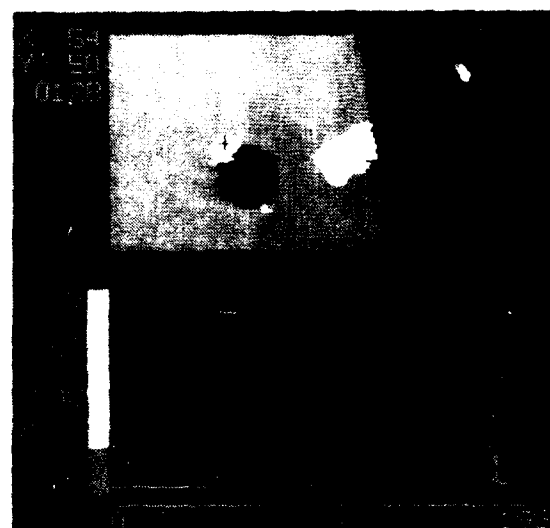
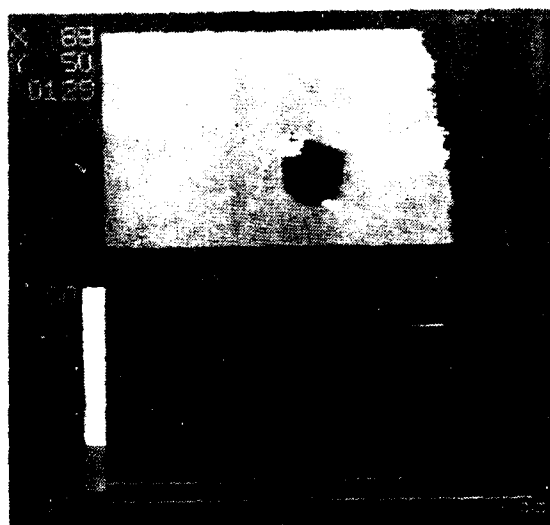
Fig. 9. Three scans from (a) - (c).

Figure 9 (a,b,c) shows the information from site 120. Not all of the 50 x 100 mm scan area was used for the image. Again a bolt hole is outlined and two delaminations are seen around it. A third larger delamination is seen at the edge of the beam. Figure 10 (a,b,c) is the image of the site just below to the scarf-joint transition. Numerous small "delaminations" can be seen, as well as several larger ones. The lower right dark area is a site not accessible for scanning. This set does not repeat as well as the previous ones. In part this is due to a small amplitude variability which exists in the instrument. Most delaminations produce a strong echo and are readily imaged. When the return signal is small, the recorded amplitude may fall on either side of the displayed threshold. For our current needs this does not appear to be a problem. The last set, Fig. 11, is the image from the bottom of area 9. Here the scan is in the scarf joint region and reflection signals from various interfaces abound. Figs. 11a and 11b represent two scans taken at slightly different gain settings. Fig. 11c is a repeat of 11b but

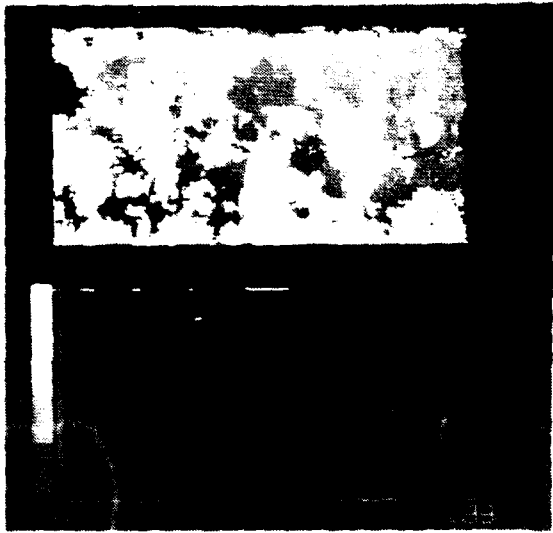
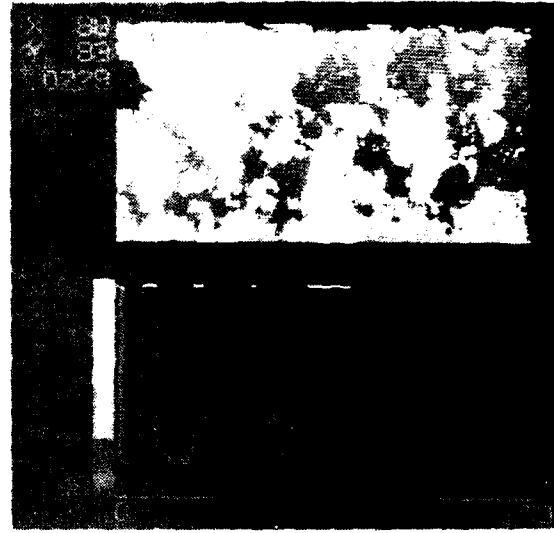
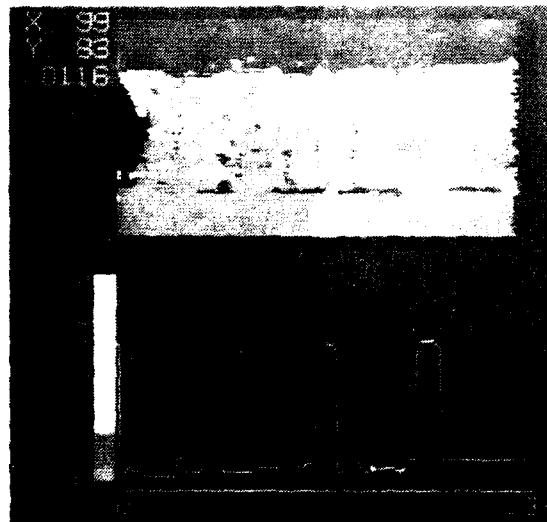
Fig. 11 - Three scans from site 9B

displayed using a different threshold and grey scale. Viewed under these conditions, the horizontal line near the top of the scan represents the transition at the scarf joint.
